Owner-Driven Housing Reconstruction, Khulna, Bangladesh

Implementing agencies :	Bangladesh Red Crescent Society (BDRCS) http://www.bdracs.org/home.php (accessed: September 2013)
Technical support by:	International Federation of Red Cross and Red Crescent Societies (IFRC) http://www.ifrc.org/ (accessed: September 2013)
Donor:	Hong Kong Red Cross Society http://www.redcross.org.hk/en/disasterrelief_prepared/international_projects/ip_appeal_update_detail.html?year=2009&id=409 (accessed: September 2013)
Context/Crisis:	Cyclone Aila, 2009
Location:	Dacope sub-district, Khulna district, Bangladesh
No. of houses:	155 new houses
Cost:	BDT 52,853 (about US\$652) excluding additional investments by beneficiaries
Type of post-disaster project:	Owner-driven reconstruction of housing destroyed by Cyclone Aila
Date completed:	July 2013

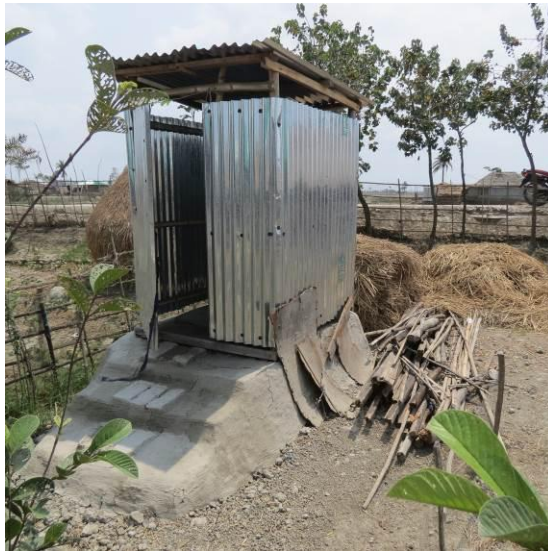
(Fig. C: Sanitary latrine with walling materials for privacy was provided to each housing beneficiary household)

- **Housing:** Each beneficiary household was provided a set of building components including six reinforced concrete (RC) posts, eighteen pieces of corrugated iron (CI) sheets together with four ridge pieces, screws, washers, nails and wire for fixing them, and timber and bamboo for the roof frame. A sanitary latrine with walling materials for privacy (see Fig. C) and a 1000-litre capacity rainwater tank (see Fig. D)

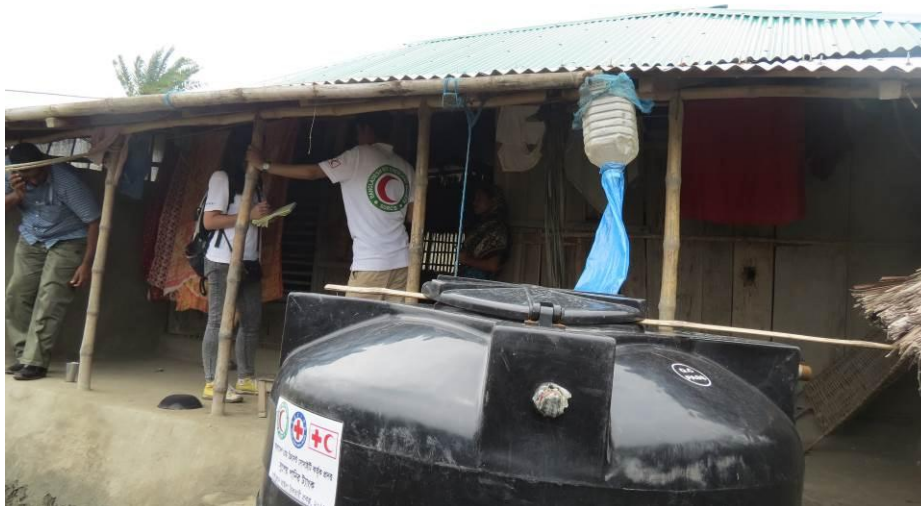
(Fig. D: 1000-litre capacity rainwater tanks were provided to housing beneficiary households)

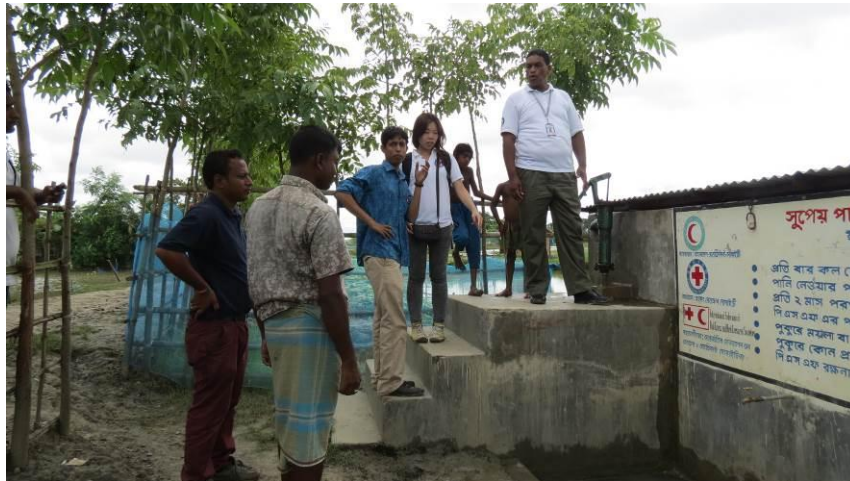
(Fig. E: New Pond Sand Filter built in the project)

level rise and consequent salinity intrusion. Therefore alternative drinking water sources including rainwater were promoted in the project. Two Pond Sand Filters (PSF) to purify rainwater collected in a pond was repaired, which had been provided by the government before the cyclone, and six new PSF was built (see Fig. E). four community rainwater tank was also built (see Fig. F). These facilities catered to the whole community beyond the 155 households that had received housing support and individual rainwater tanks.

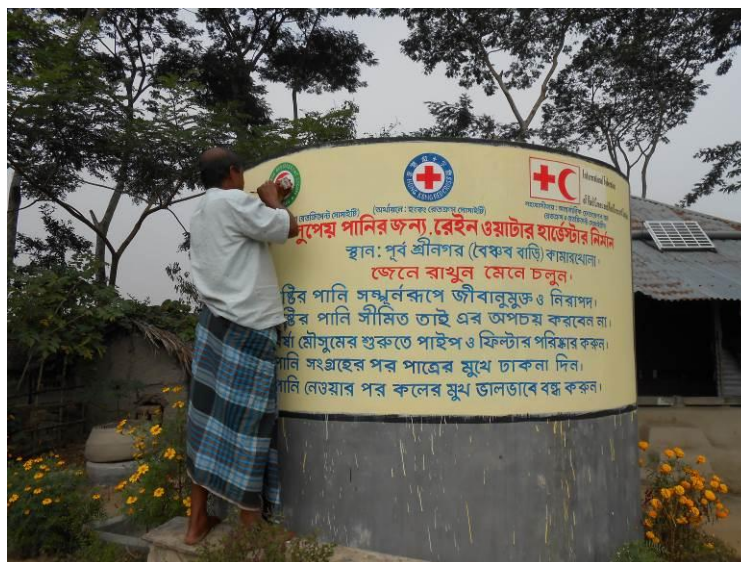
(Fig. F: Community rainwater tank)

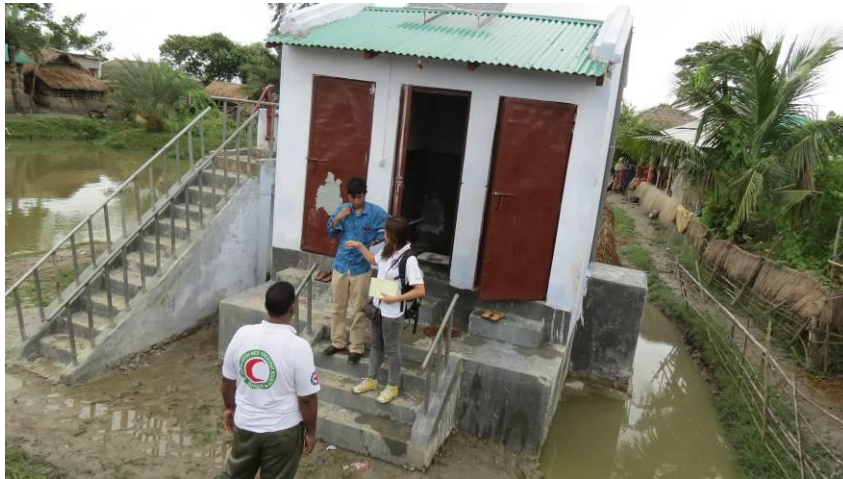
(Fig. G: Community toilet/bathroom)

Similarly three community toilets and bathroom consisting of six chambers (three male and three female) were built to serve the whole community (see Fig. G). Each male and female section had a bathroom chamber, latrine chamber and a children's latrine chamber (with a smaller toilet pan).

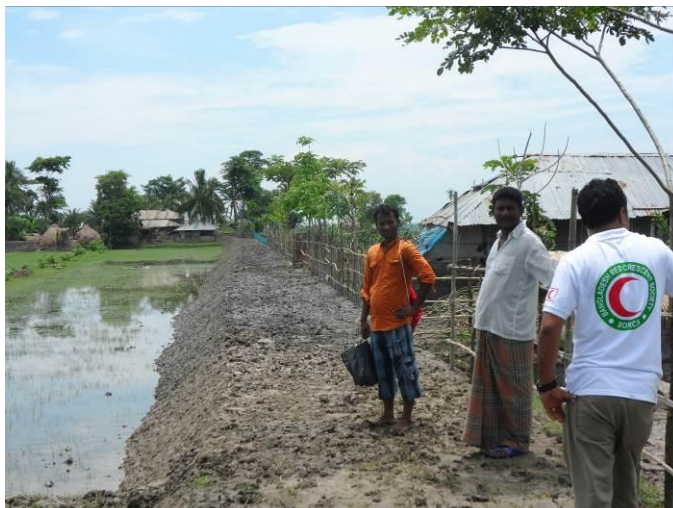
(Fig. H: Roads such as this were built through the cash-for-work program and also served as dykes)

- **Disaster risk reduction (DRR):** Trees were planted on the sides of the newly constructed risk roads to stabilise the slopes and prevent erosion. These roads also served as dykes (see Fig. H), so stabilising them protected them from collapsing as the dykes had done in the cyclone. A household level awareness campaign on understanding cyclone early warning and evacuation was conducted. The Cyclone Preparedness Program (CPP), a large volunteer network of BDRCS, was extended to the area by providing training and early warning dissemination equipment to community volunteers.

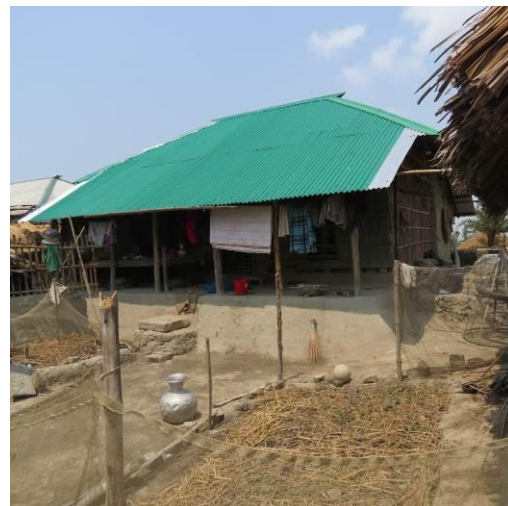
(Fig. K: Raised house plinths were built to protect from flooding)

a metre or so above the ground level to protect the houses from flooding (see Fig. K).

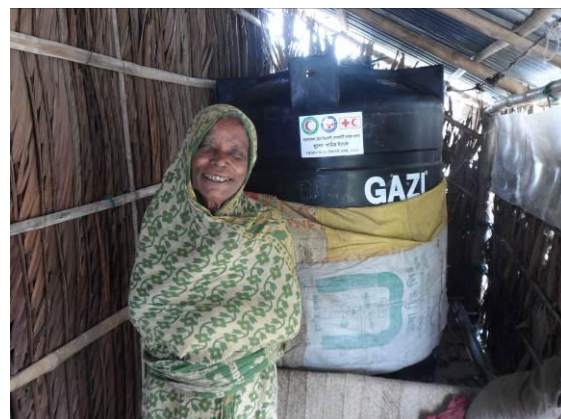
(Fig. L: This rainwater tank was brought onto the veranda to keep it safe from theft)

- In a context of widespread impoverishment, security was a key challenge. For example, beneficiaries feared theft of their rainwater tanks installed outside their houses. Some of them had already lifted the tanks onto the veranda (see Fig. L) closer to the house to keep them safe. Thus there was a need for rigorous surveillance of the community infrastructure provided in the project, adding to the community's workload.
